# Caught by a Körting...

Les Lawry-Johns

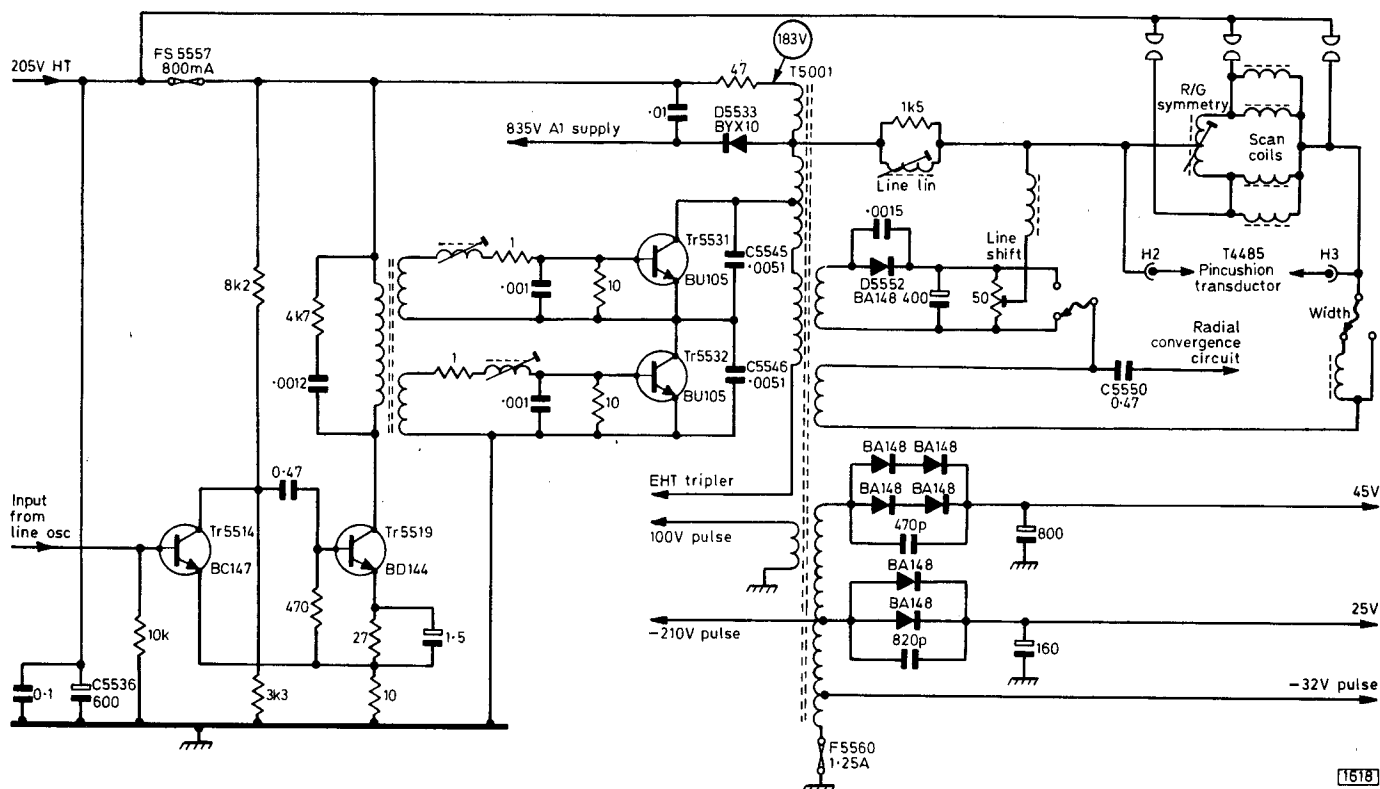
Fig. 3: The trigger amplifier (Tr5514), driver (Tr5519) and line output stages. The beam limiter circuit is also mounted on the line scan panel but is not shown here. There have been several production modifications.

keep 2SC643A types in stock since they replace all these and a few others and so are very handy transistors to have around. But it's quite likely that the transistors are not at fault. You can check the capacitors, and the trigger amplifier and driver transistors, but by this time it will be sinking in that the culprit is that thing on the rear end with all the windings on it. Yes, just one shorted turn is all you need to cause the transistors to pass excessive current and dampen things down a bit. Now tell the customer how much that nice simple job is going to cost.

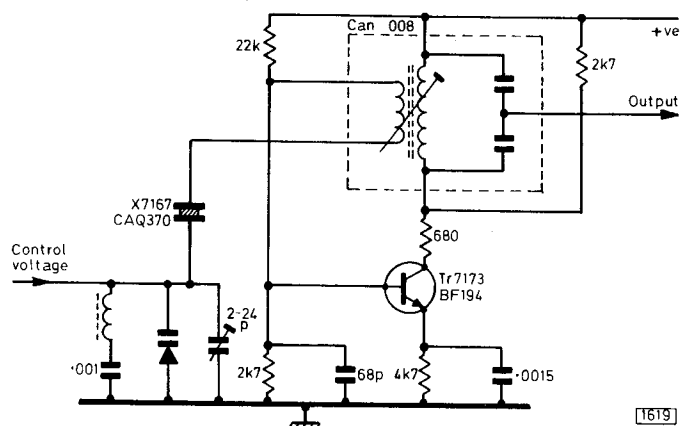
Fig. 4: Decoder reference oscillator circuit.

particular area. With this in one hand and your aerosol freezer in the other, heat up the area of can 008 which is next to the CAQ370 crystal, to the left of the luminance delay line (see circuit, Fig. 4). If this causes the colour to drop out just check the setting of the core of 008: half a turn may restore the colour no matter how much heat and freezing is applied. You may need a new crystal or maybe any number of other things, but it's worth checking the core first to save an awful lot of time and frustration.

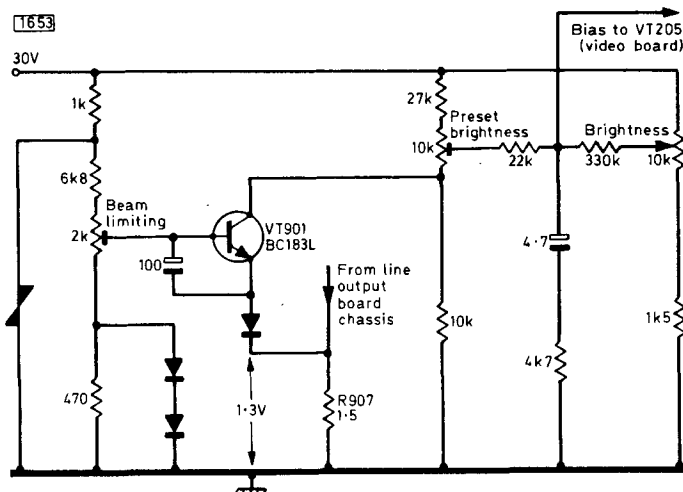
**Fig. 1: The beam limiter circuit, Thorn 3000/3500 chasis.**

With the set up on the bench there was neither picture nor raster, but there was a funny arcing noise every now and again from the beam limiter board. On trying to take a voltage measurement across R907 (see Fig. 1) we found that it was loose. This is one of the key test points on the chassis as it shows the current taken by the line output stage: the voltage across the  $1.5\Omega$  resistor should be  $1.3V$  if all is well. If the reading is higher, either the timebase is taking too much current or the resistor has risen in value. You may say that a low-value wirewound resistor does not change value. But it can, and has on more than one occasion to cause loss of brightness. This time however it was loose and the solder had decomposed.

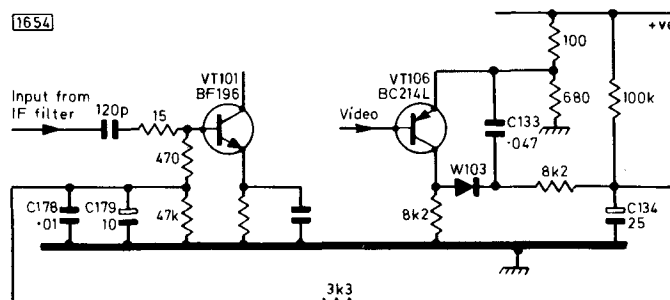
*Fig. 2: The first controlled i.f. stage VT101 and the a.g.c. detector/amplifier transistor VT106. C134 was omitted in later production chassis.*

We then concluded that we were up against an a.g.c. fault or an open-circuit decoupler in the supply line. Checking the latter didn't help much but bridging C179 seemed to help – bridging it with an electrolytic that is, not with the 0.01 $\mu$ F capacitor, twit. Moving down the chassis, we next bridged C134 and this cleared the condition. Now when the base of VT101 was bridged with the 0.01 $\mu$ F capacitor the

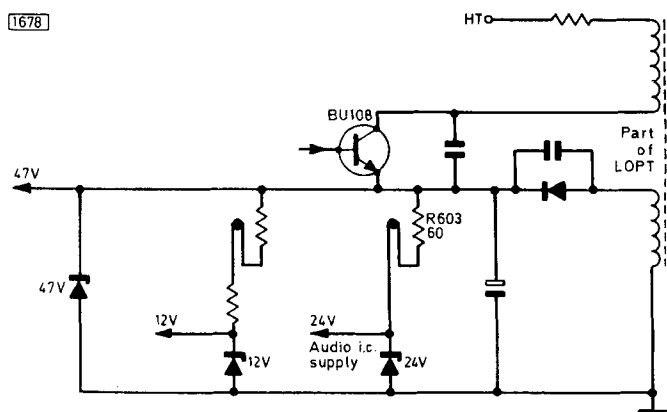
**Fig. 1: What kept blowing the mains fuse, and made R603 go open-circuit? GEC Model C2111.**

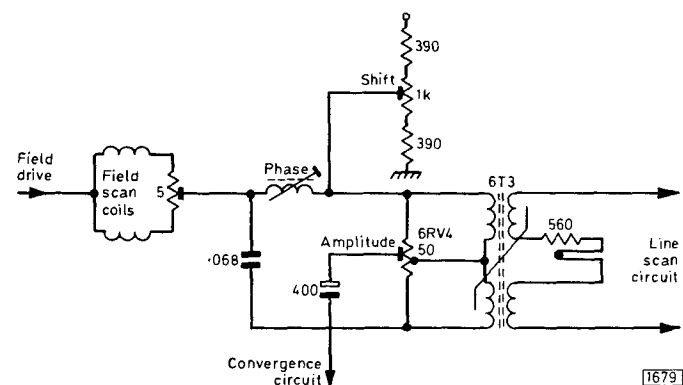
*Fig. 2: Bush Model CTV194. The transducer 6T3 went up in smoke, then 6RV4 caused nasty things.*

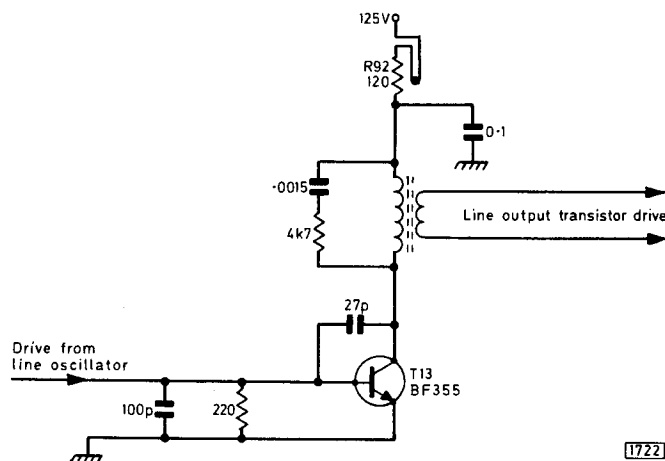
Fig. 1: Line driver stage, ITT CVC20 chassis.

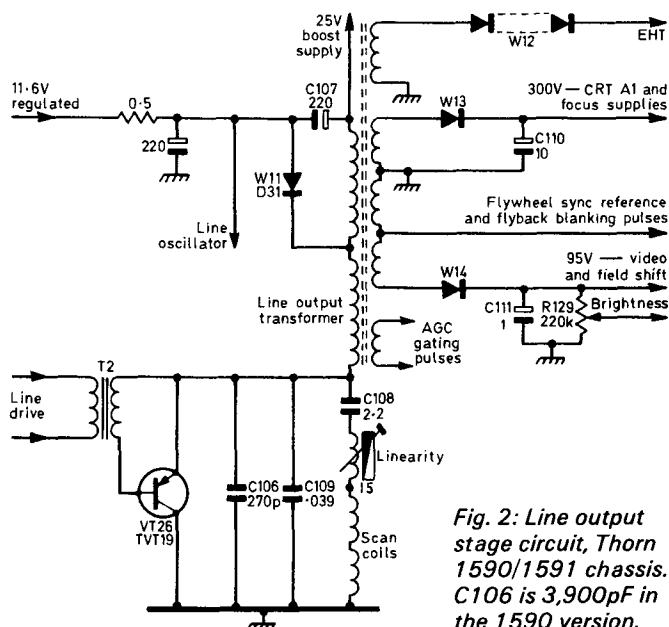
Fig. 2: Line output stage circuit, Thorn 1590/1591 chassis. C106 is 3,900pF in the 1590 version.

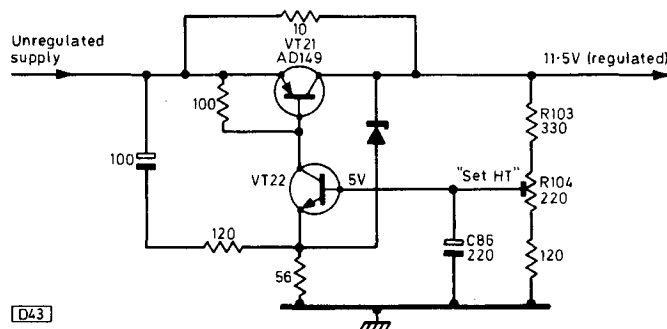
**Fig. 1: L.T. regulator circuit, Thorn 1590/1591 chassis.**

VT22 should have 5V at its base when the supply line is 11.5V, and this 5V is initially set up by the preset control R104. The transistor and its associated components seemed to be in order when checked with the ohmmeter, so we switched on again and checked for the 5V at the VT22 base. The 5V was anything but 5V (but didn't exceed it). The

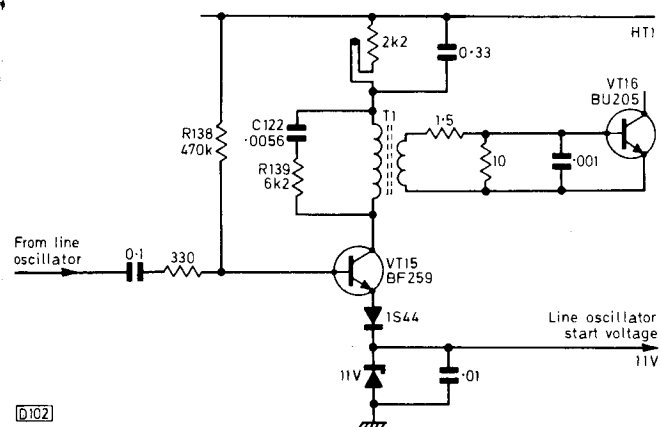
Fig. 1: Line driver stage, Thorn 1600 chassis. In earlier versions VT15 was type BF337.

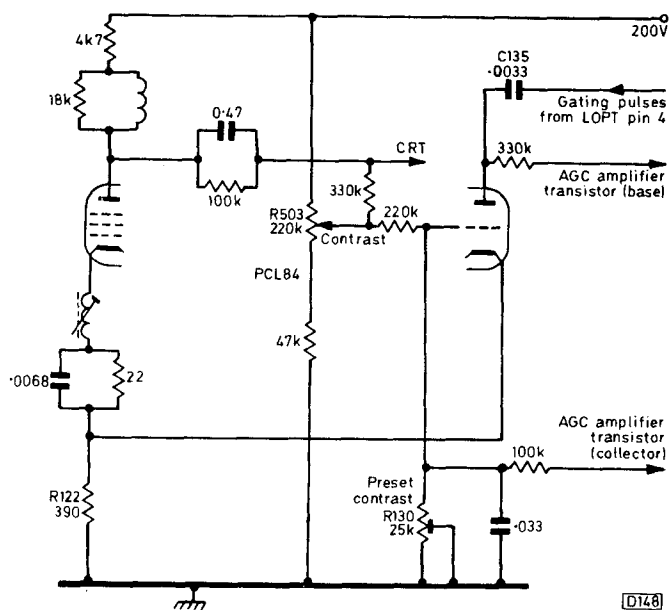
Fig. 1: A.G.C. gating circuit used in the Waltham Model W125 – the PCL84 triode is gated at its anode.

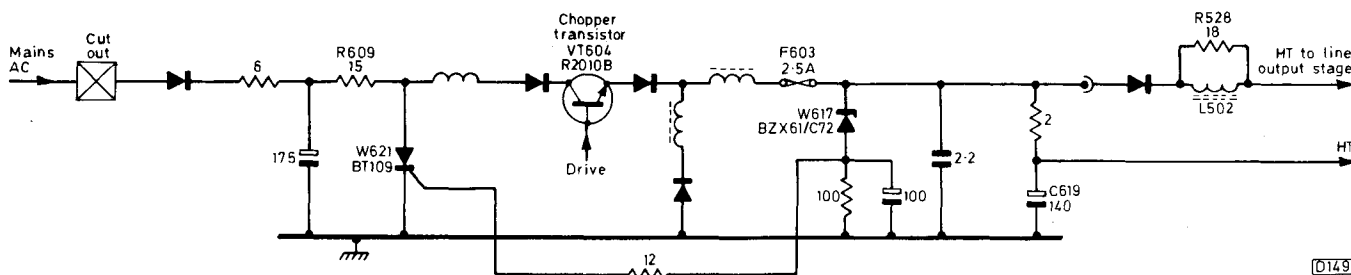
Fig. 2: Path from the mains input to the line output stage h.t. supply point in the Thorn 3500 chassis. Various problems included the core having fallen out of L502.

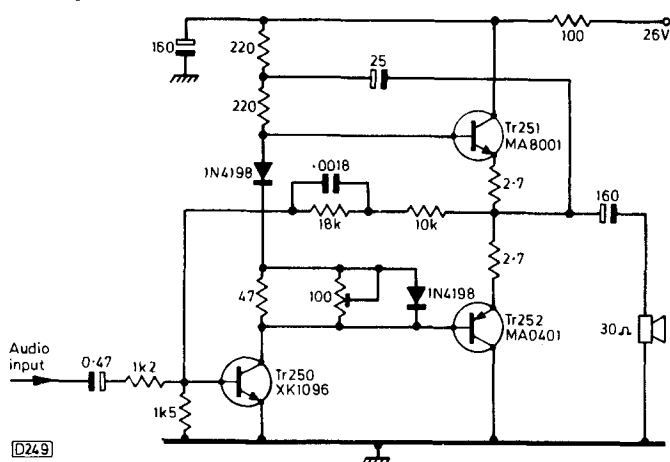
Fig. 1: The audio circuit used in some early Decca single-standard colour sets (20 series chassis). Most of the rest of the circuitry is similar to later versions of the Decca CTV25 series, though a different set of component reference numbers was used. Sets using this chassis are the CS2225, CS2227 and CS2520. Another difference is the use of an MC1351P intercarrier sound i.c.

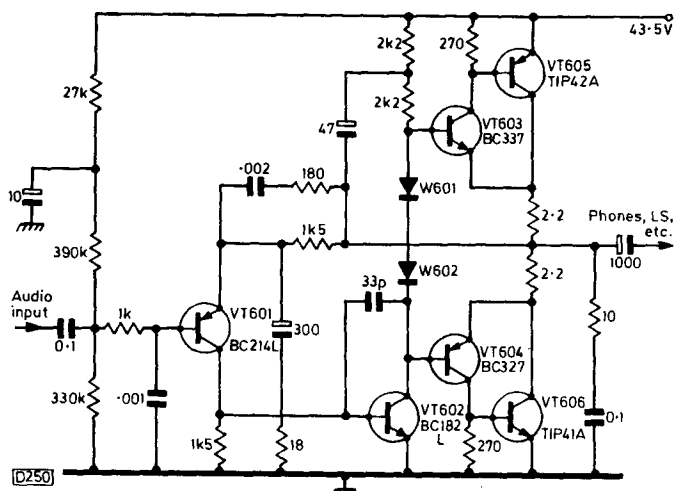
Fig. 2: Some contrasting audio circuitry, used in a Thorn music centre. One channel only of this stereo unit shown. Both channels were dead, for different reasons.

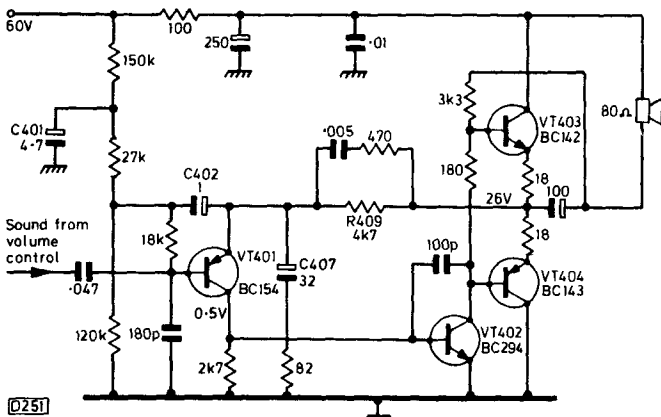
Fig. 3: Another collection of d.c.-coupled audio stages, this time the circuit used in the Thorn 3000/3500 colour chassis. Odd voltages were caused by printed panel defects rather than component failures.

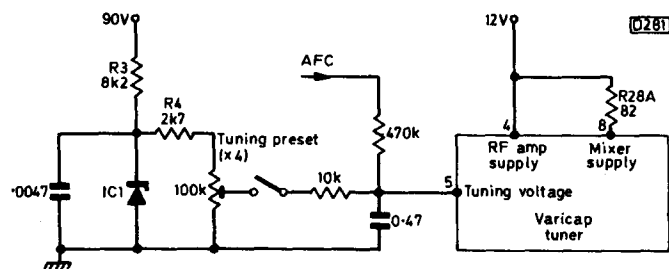
Fig. 1: Varicap tuner supplies, ITT VC300 chassis.

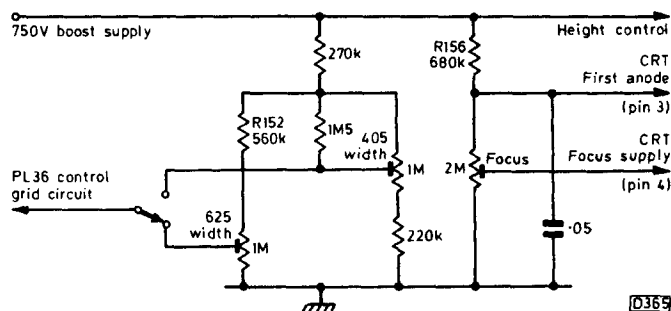
Fig. 1: Boost supply feeds in the ITT/KB VC4 and similar dual-standard monochrome chassis.

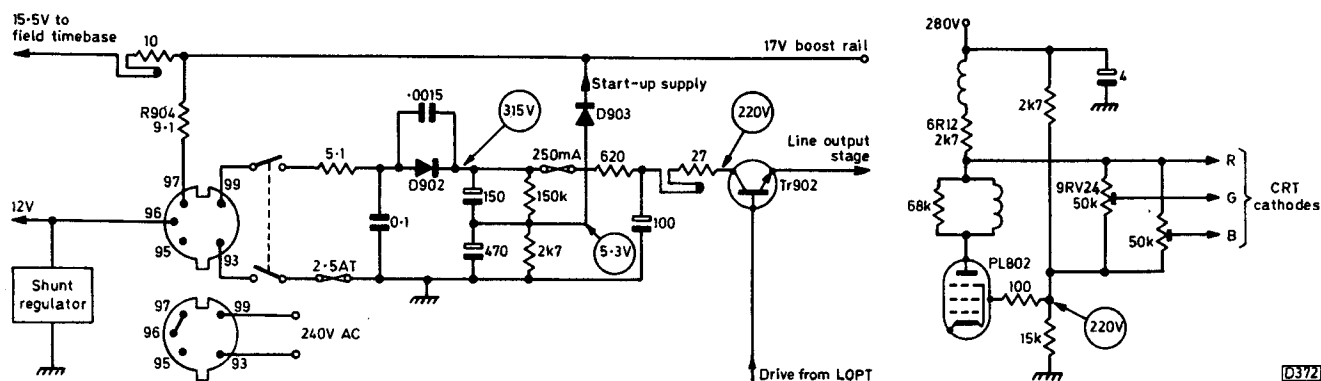
Fig. 1 (left): Since all the stages in the Indesit T12LGB monochrome portable are powered from supplies obtained from the line output stage, a start-up system is required. At switch on diode D903 feeds a reduced (5.3V) voltage to the boost rail to get the line oscillator, which is powered from the stabilised 12V rail, to start. Once the line output stage comes into operation, the 17V boost supply is developed and D903 switches off. With no link between connections 96/97 to the mains plug, the line oscillator can't start. Hence no results.

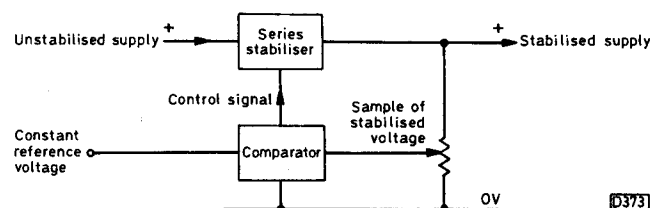
Fig. 1: Basic features of a series stabiliser circuit.

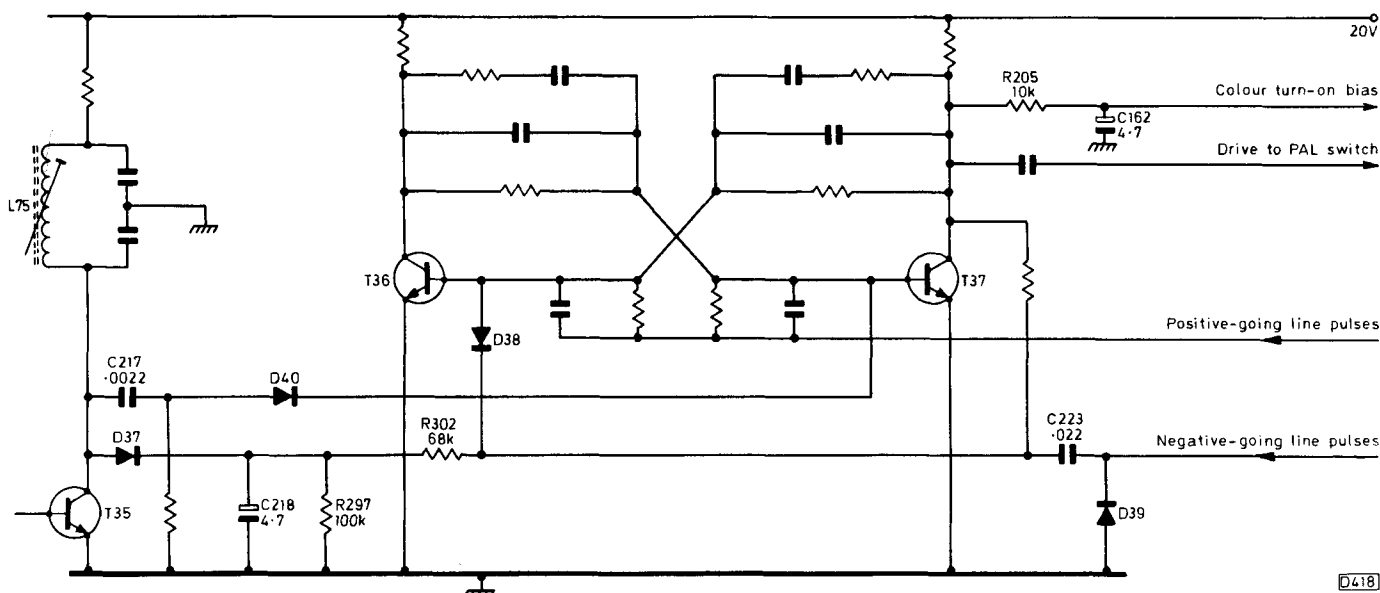
Fig. 1: The ident amplifier (T35), bistable (T36/37) and colour-killer arrangements in the ITC CVC5 chassis. On colour, the squarewave produced at the collector of T37 is smoothed by R205/C162 and used as a turn-on bias for the delay line driver transistor in the chrominance channel, with the positive-going line pulses triggering the bistable. This means that on monochrome the bistable circuit has to be stopped. This is done by applying negative-going line pulses, clipped by D39, to the base of T36 via C223 and D38 to ensure that it remains cut-off. T37 will then be permanently on, and there'll be no colour turn-on bias. On colour, D37 rectifies the ident signal produced by L75, and the positive bias developed across its reservoir capacitor C218 cuts D38 off so that the negative-going pulses no longer reach T36's base. D40 provides the ident action on colour to ensure that T36/7 switch in synchronism with the V signal line-by-line polarity inversions.

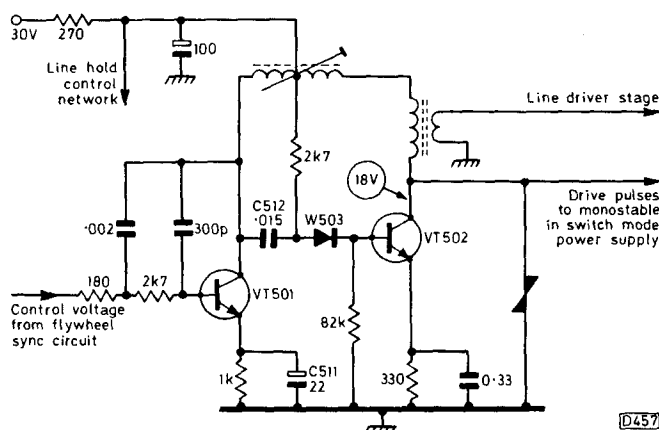
Fig. 2: Line oscillator circuit, Thorn 3000/3500 chassis. The output goes to the driver stage and also triggers the monostable multivibrator in the switch-mode power supply circuit. The trouble was no results, with a funny whistle. As a result of the tuning capacitor C512 going short-circuit, VT502 was excessively biased with about 10V at each of its electrodes.

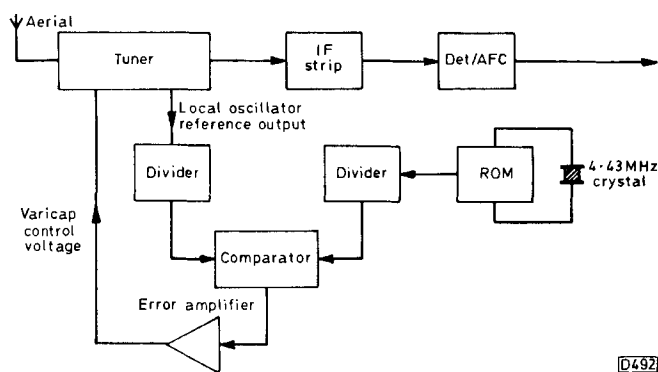
Fig. 14: Block diagram showing the basic principle of the Plessey direct channel tuning system. The local oscillator frequency is compared with the selected channel presented in digital form by the ROM, the difference signal being amplified and used to pull the local oscillator into lock.

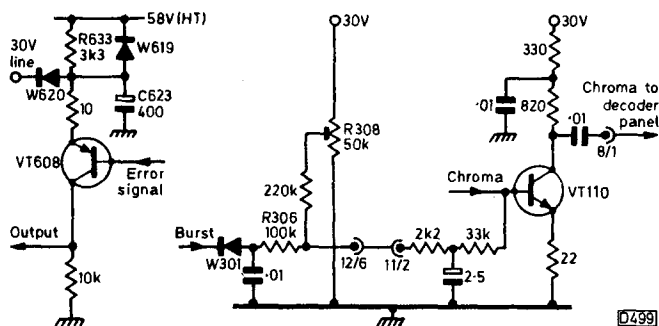
Fig. 1 (left): Power supply error amplifier circuit, Thorn 3000 chassis. W620 clamps the emitter of VT608 to the 30V rail. The time-constant of R633-C623 ensures that VT608 is cut off when the set is switched on, giving a slow-start action. W619 is included to discharge C623 rapidly when the set is switched off.

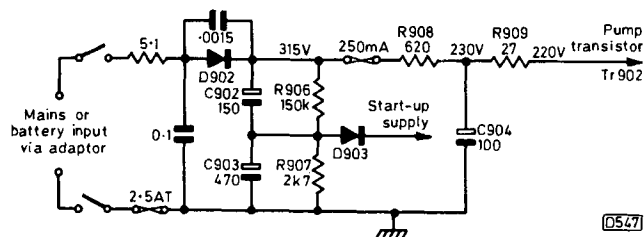
*Fig. 1: Mains input/h.t. rectifier circuit used in the Indesit T12LGB portable. R909 is a fusible type in later production. A problem we've had on occasion is the h.t. filter capacitor C904 going open-circuit: the symptoms are a small picture after a slow tube warm up, with the h.t. line low at about 7-5V. R906/7 provide a 5-8V start-up supply to get the line oscillator going.*

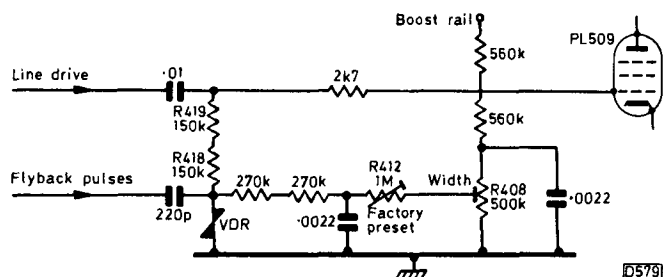
Fig. 1: The width control circuit used in the ITT CVC5 and subsequent hybrid colour chassis. The design is conventional, but care has been taken over its implementation. Pairs of resistors are used to reduce the voltage stress across the individual resistors, and the 0.0022µF decoupling capacitors are included to protect the factory and dealer preset width controls against high pulse voltages.

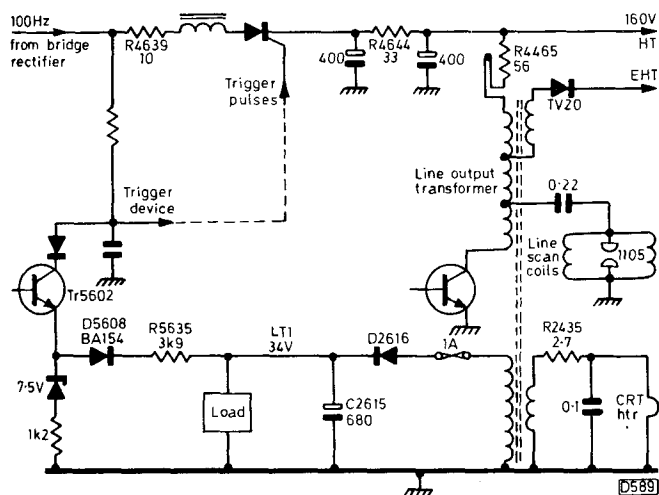
Fig. 1: Simplified circuitry showing the interconnections between the power supplies and the line output stage in the Philips 320 solid-state monochrome chassis.

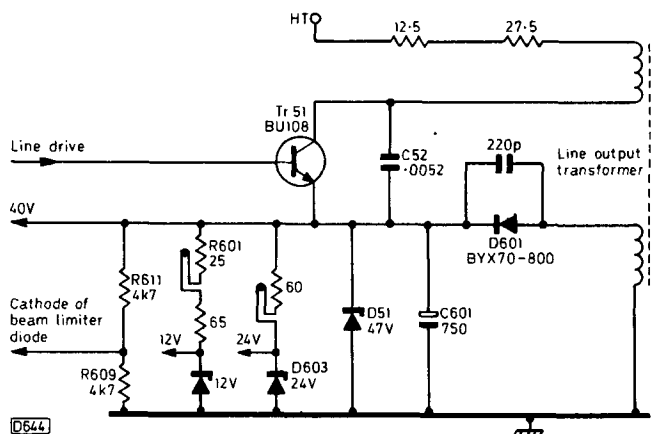
*Fig. 1: Line output transistor circuit, GEC C2110 series. The transistor sits on a 40V line produced by D601/C601. 12 and 24V supplies are derived from the 40V line via droppers and zener diodes. D603 is often responsible for no sound or distorted sound.*

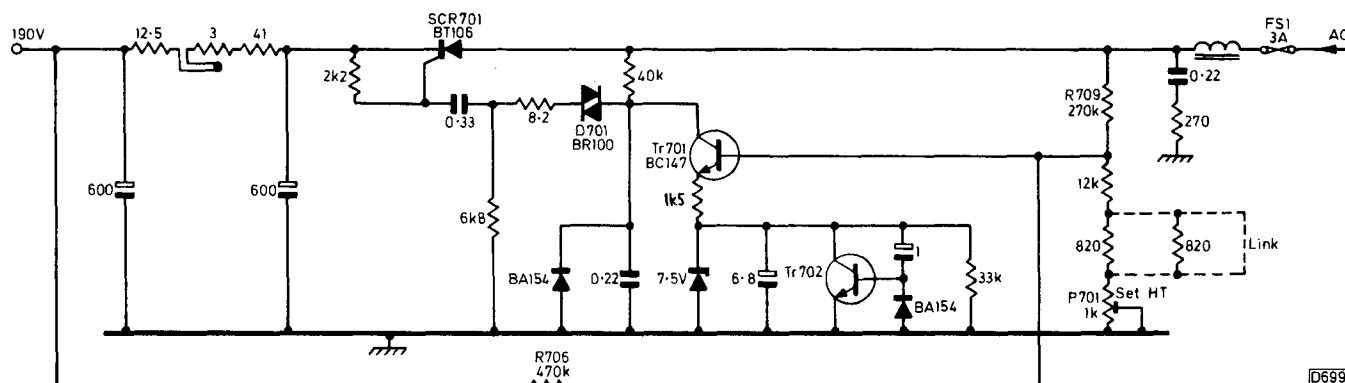
Fig. 1: H.T. supply circuit, GEC C2110 series. Early versions differ in several ways.

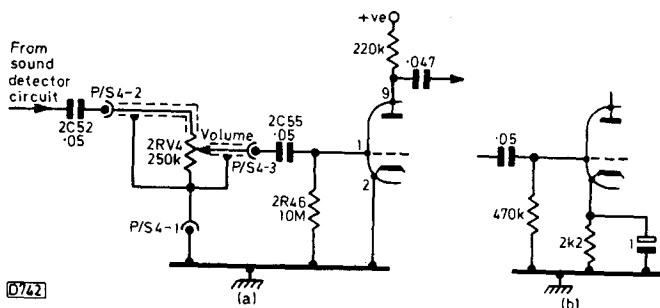
Fig. 1: Triode audio amplifier stage used in the Rank A774 chassis (a). A difficult case of hum on sound could be cured by decoupling the triode's control grid (pin 1). The only workable cure we could find was to introduce selective negative feedback in the triode's cathode circuit (b). The 1 $\mu$ F cathode bypass capacitor provides negligible decoupling at 50Hz. Introducing the 2.2k $\Omega$  cathode bias resistor makes it necessary to reduce the value of the grid leak resistor to about 470k $\Omega$ .

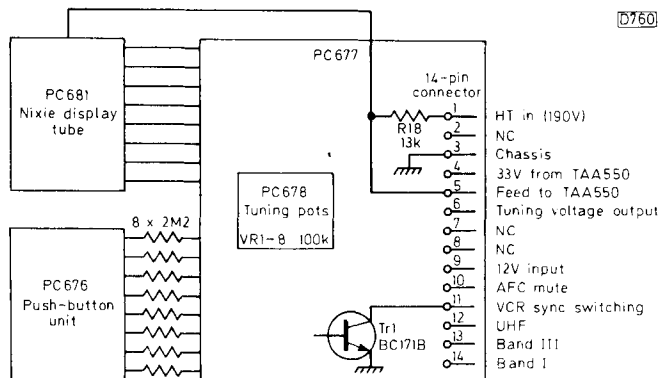
Fig. 1: The panel arrangement used in the surplus varicap tuner control unit, and the connections to the fourteen-pin connector.

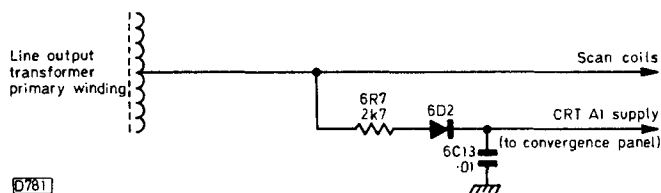
Fig. 1: A dry-joint on the c.r.t. first anode supply reservoir capacitor 6C13 caused intermittent loss of brightness in Mr. Bristol's Bush colour set (A823 chassis).

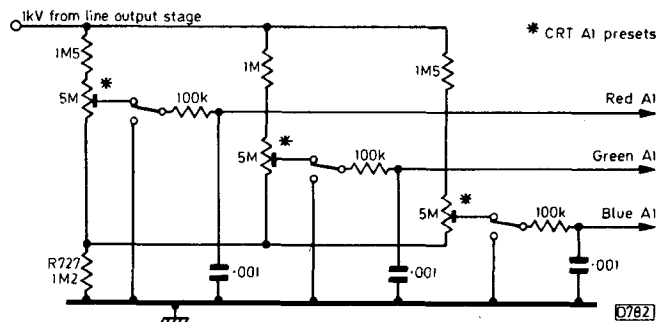
Fig. 2: A particularly nasty one this, on the Thorn 3000 chassis. When warm, R727 would go open-circuit, with the result that the c.r.t.'s first anode voltages became excessive. The symptoms were loss of focus, the picture becoming a bright blur then disappearing.

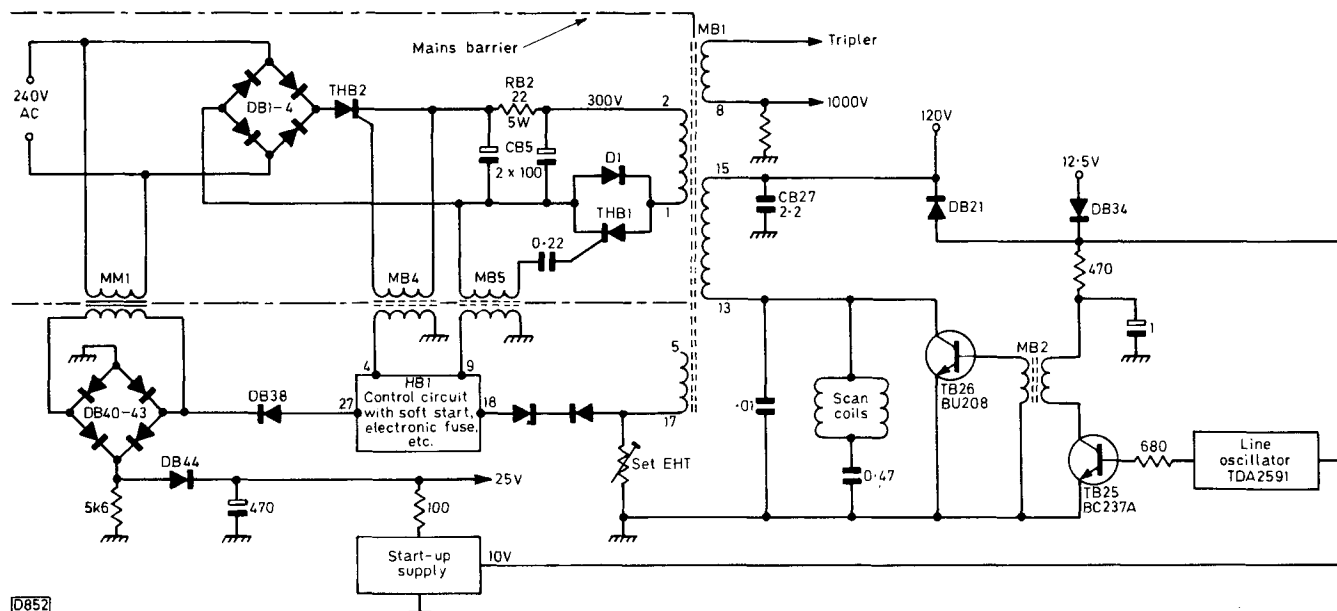
*Fig. 3: The Ipsalo arrangement in greater detail, showing the mains barrier system and the start-up feeds.*

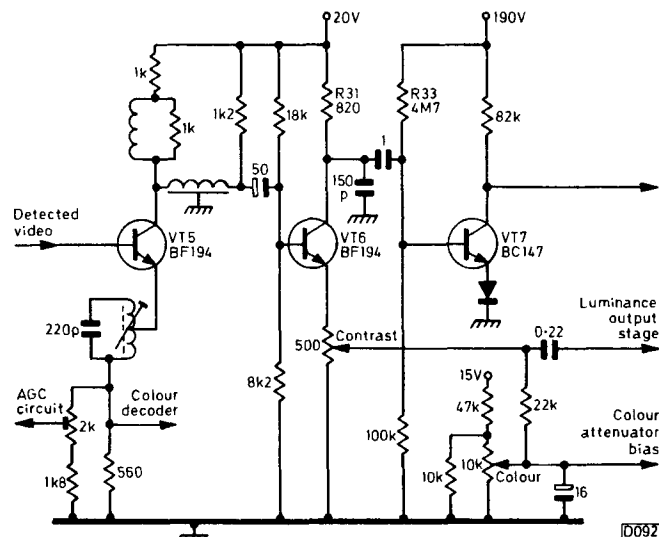
Fig. 1: Video and sync separator circuits used in Pye hybrid colour chassis. The detected video is fed to VT5, which drives VT6 from its collector and provides feeds to the decoder and a.g.c. circuits from its emitter – a separate detector is used for sound. VT6 in turn drives the luminance output stage from its emitter, via the contrast control, and the sync separator transistor VT7 from its collector. R33 provides VT7 with base bias so that it saturates when a sync pulse arrives.

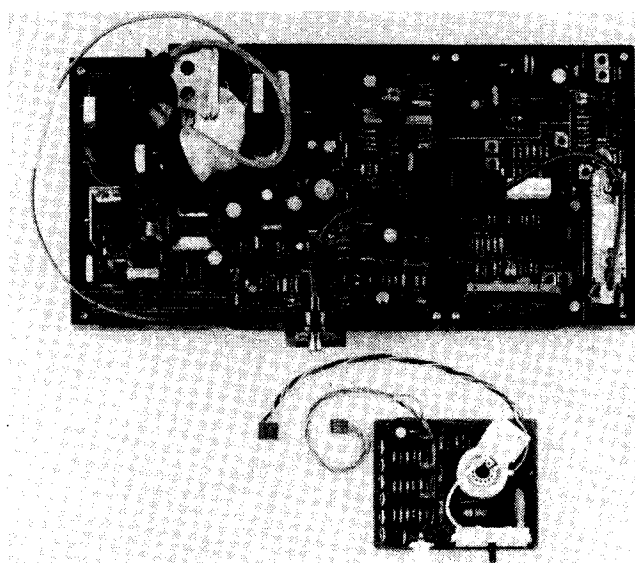
The main panel and c.r.t. base panel used in the Fidelity CTV14R 14in. colour transportable. The low component count and neat layout should make any servicing required easy.

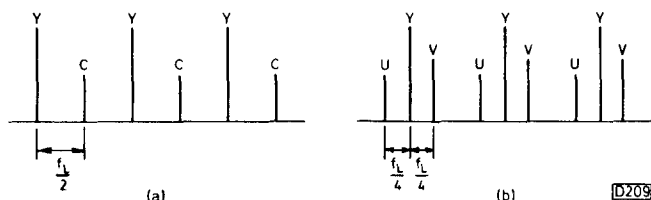
Fig. 3: Comparison between NTSC (a) and PAL (b) video signal spectra in the vicinity of the colour subcarrier.

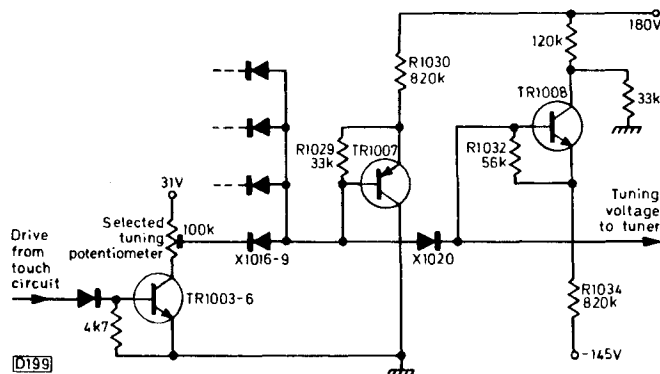
*Fig. 1: Tuning voltage selection arrangement used in the Teleton Model C18BS.*

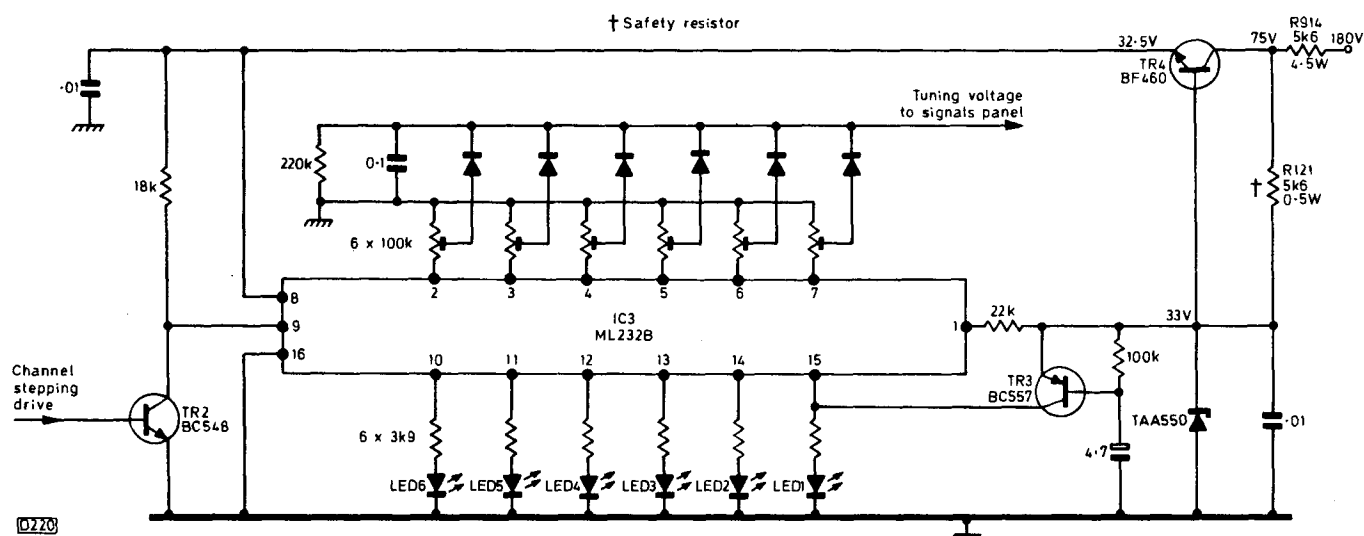
*Fig. 1: Channel selection circuit, Fidelity Model CTV14R.*

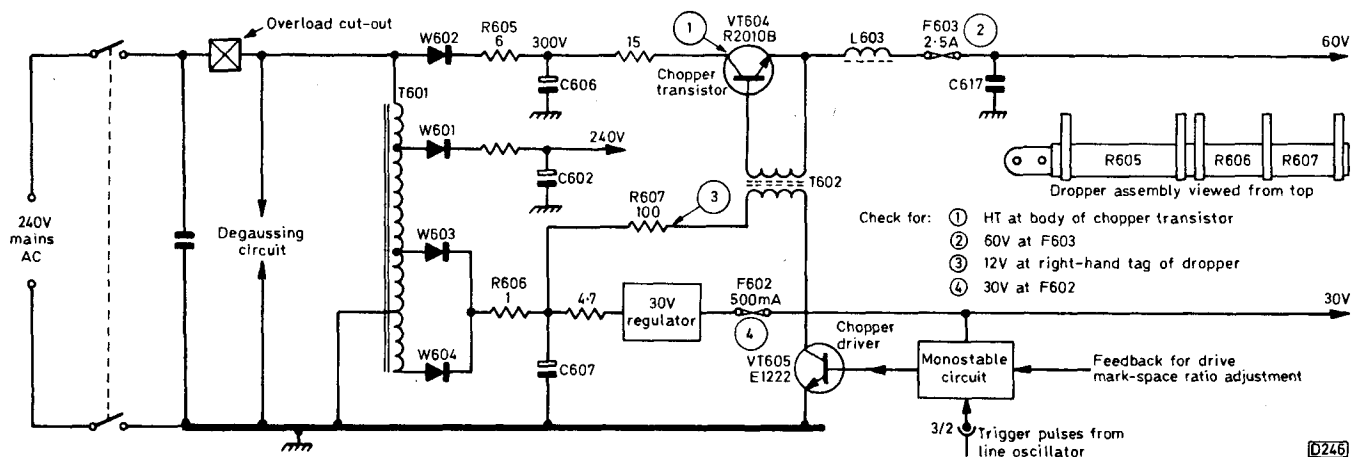
Fig. 1: Quick checks on the Thorn 3000/3500 chassis power supply module (simplified circuit). H.T. at the body of the chopper transistor but no 60V supply at F603 means that either the fuse or the transistor is open-circuit or the transistor is without drive. If the fuse and chopper transistor are o.k., check the 12V supply to the driver transistor, the 30V supply to the monostable circuit etc., and for the presence of trigger pulses at connector 3/2 and drive to VT605.

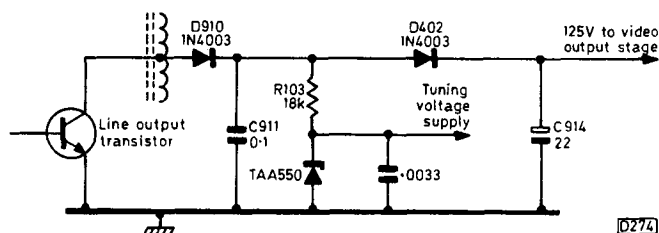
Fig. 1: Method of obtaining the h.t. supplies in the Indesit T12SGB monochrome portable.

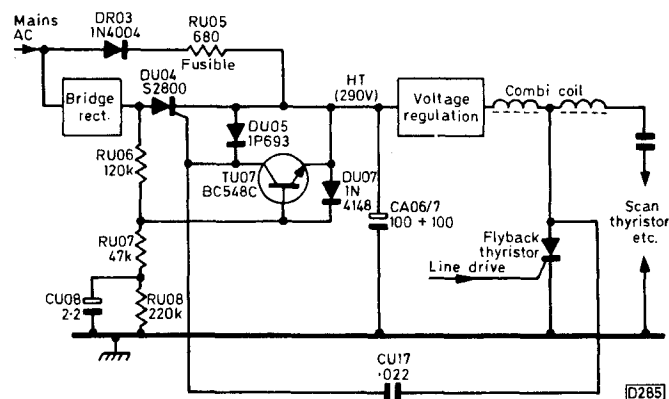
Fig. 1: Soft-start system used in the Ferguson Model 3787 colour portable. When the set is switched on, the reservoir capacitors CA06/7 are charged slowly via DR03 and RU05. As the h.t. voltage rises, the line timebase will come into operation, the pulses at the anode of the flyback thyristor being fed back to the gate of DU04 via CU17. During the soft-start period the voltage at the base of transistor TU07 will exceed that at its emitter: as a result, the pulses are shorted out by TU07 and do not fire DU04. Once the h.t. line has risen to its normal voltage, TU07 will be cut off and DU04 will be triggered, passing the 100Hz pulses from the bridge rectifier to CA06/7. Diodes DU05 and DU07 provide junction protection for TU07. CU08/RU08 ensure that the soft-start action occurs when the set is switched off and on quickly.

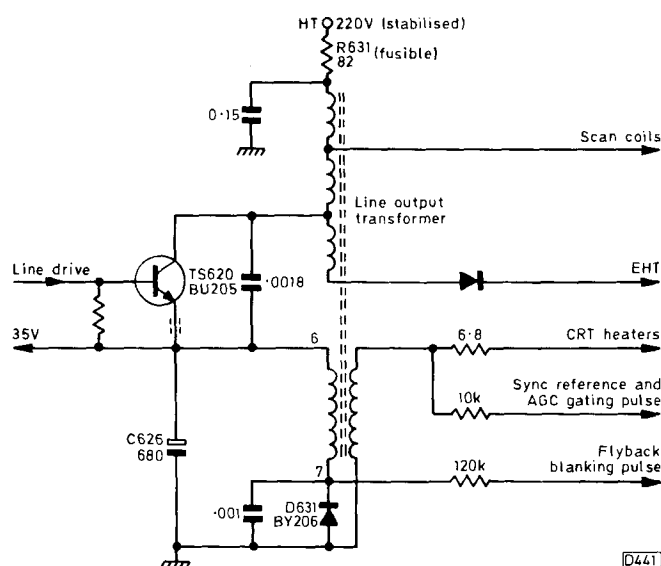
Fig. 1: Line output stage circuit used in the Pye 176 solid-state monochrome chassis (version with A61-520W c.r.t.).

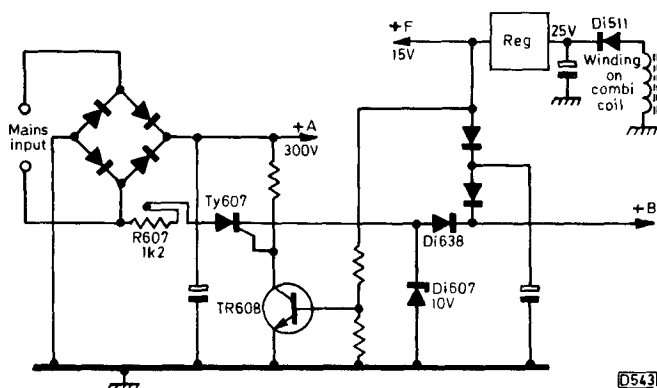
Fig. 3: Start-up circuit used in the Grundig GSC100 chassis. When the line output stage comes into operation the +F supply is developed and TR608 conducts, shorting the gate of the start-up thyristor Ty607 which thus switches off.

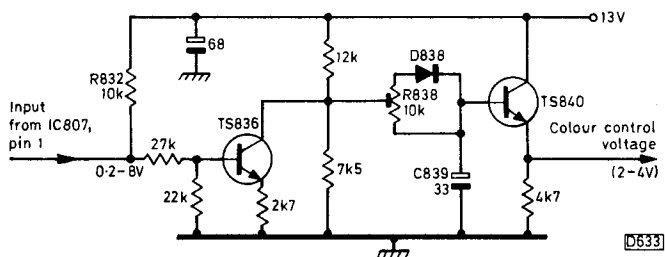
Fig. 1: Preset colour control circuit, Philips KT3 chassis (remote control version).

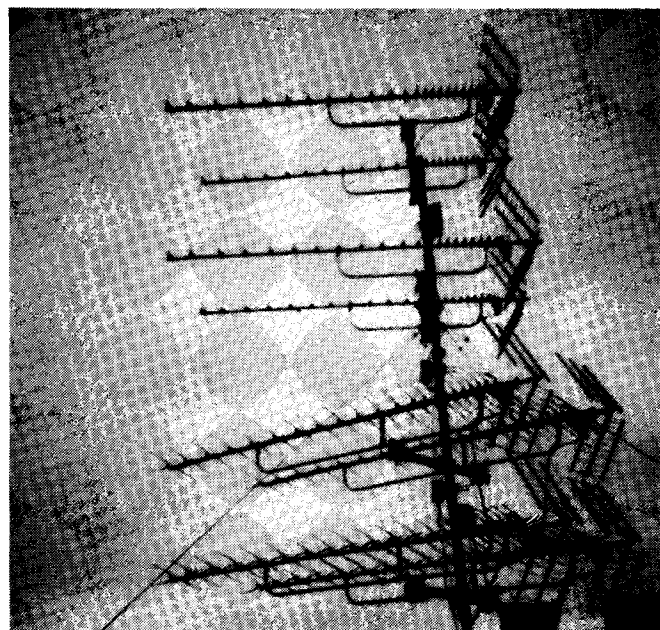
Michael Rahe's aerial installation at Tramore, Waterford, Eire. The upper quad stack of group B Triax aerals is for reception from Presley, Wales, the lower group A stack for reception from Caradon Hill. For much of the time reception is good using a 25dB gain, 1.4dB noise figure amplifier.

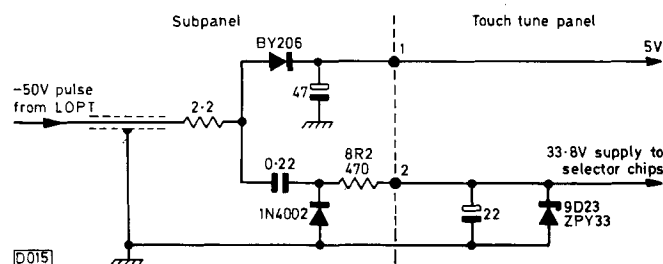
Fig. 1: Rank T20 chassis, touch tune power supply circuit. The tuning voltage is separately derived.

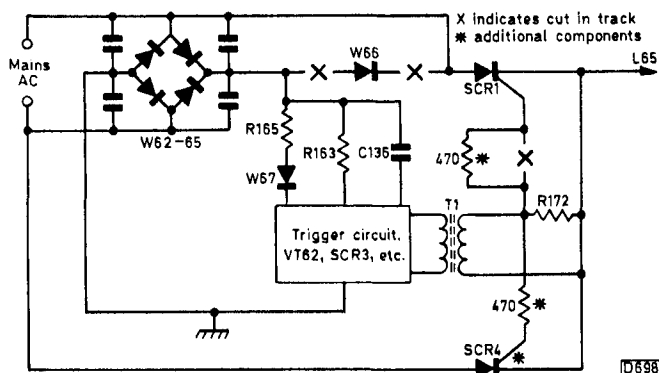
Fig. 1: Thyristor power supply modification for the Ferguson TX9 chassis. Note that in the PC1040 version W66 is omitted and R165/W67 are interchanged.

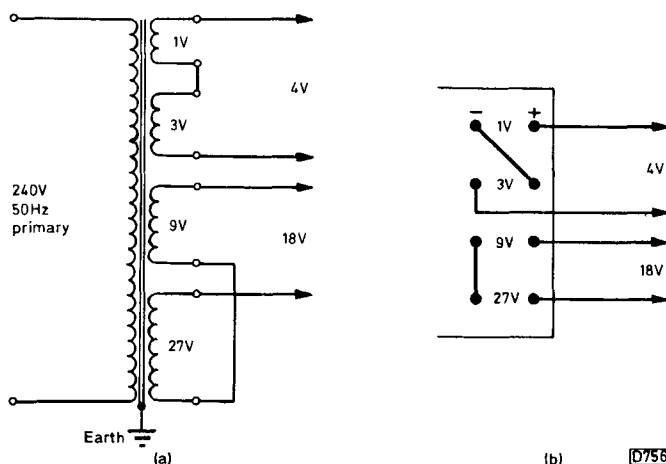
Fig. 2: Transformer windings, showing how to obtain 4V and 18V outputs (a). Links for 4V and 18V (b).

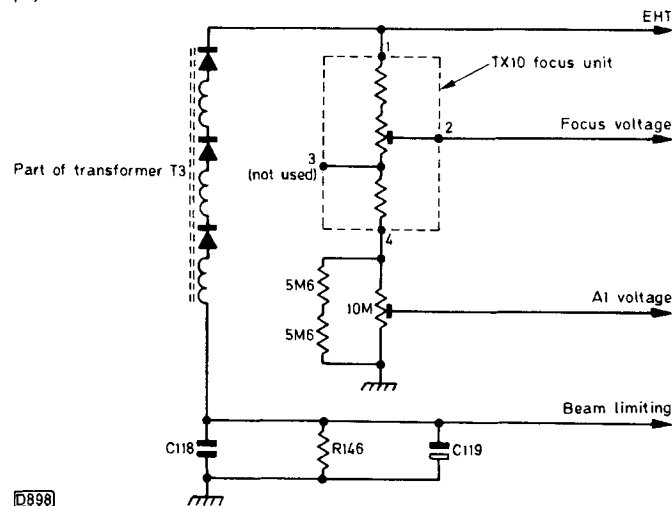
Fig. 3: Modified circuit using the focus unit used in the Ferguson TX10 chassis.

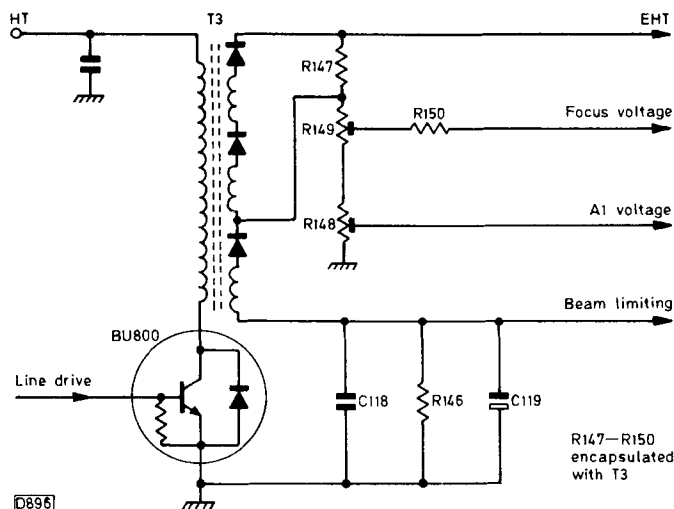
Fig. 1: Original e.h.t., focus and first anode supply circuitry used in the Siemens Model FF306.

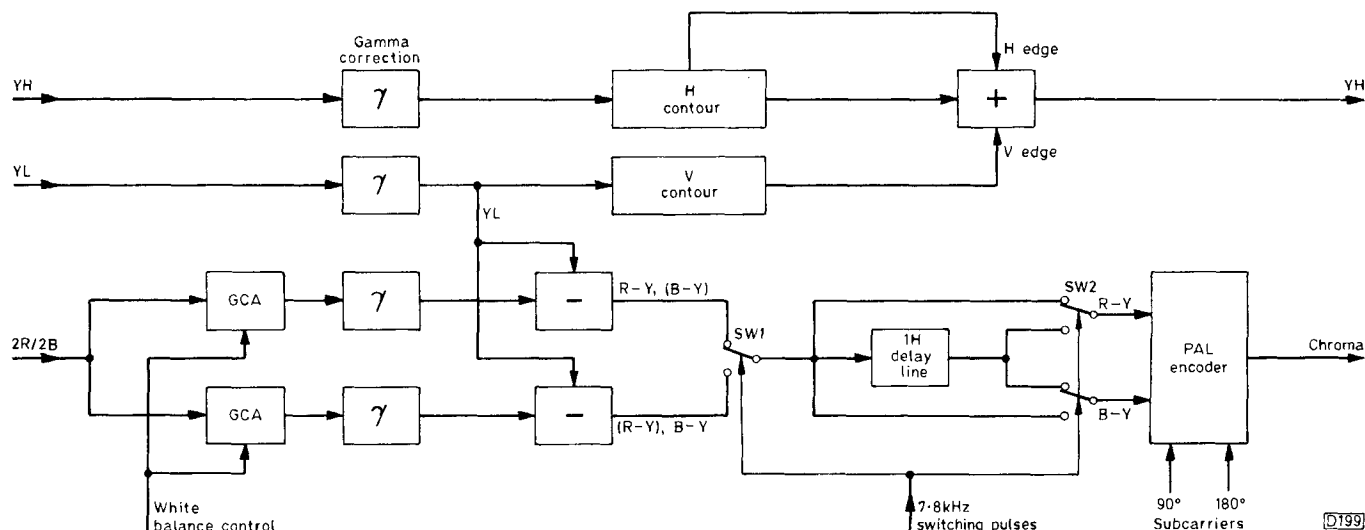
Fig. 9: Block diagram of the circuitry used to produce Y plus simultaneous colour-difference signals.
